DESKTOP GEOHAZARD REPORT

Overland Pass Energy East Project

Sedgwick County, Colorado

May 24, 2024

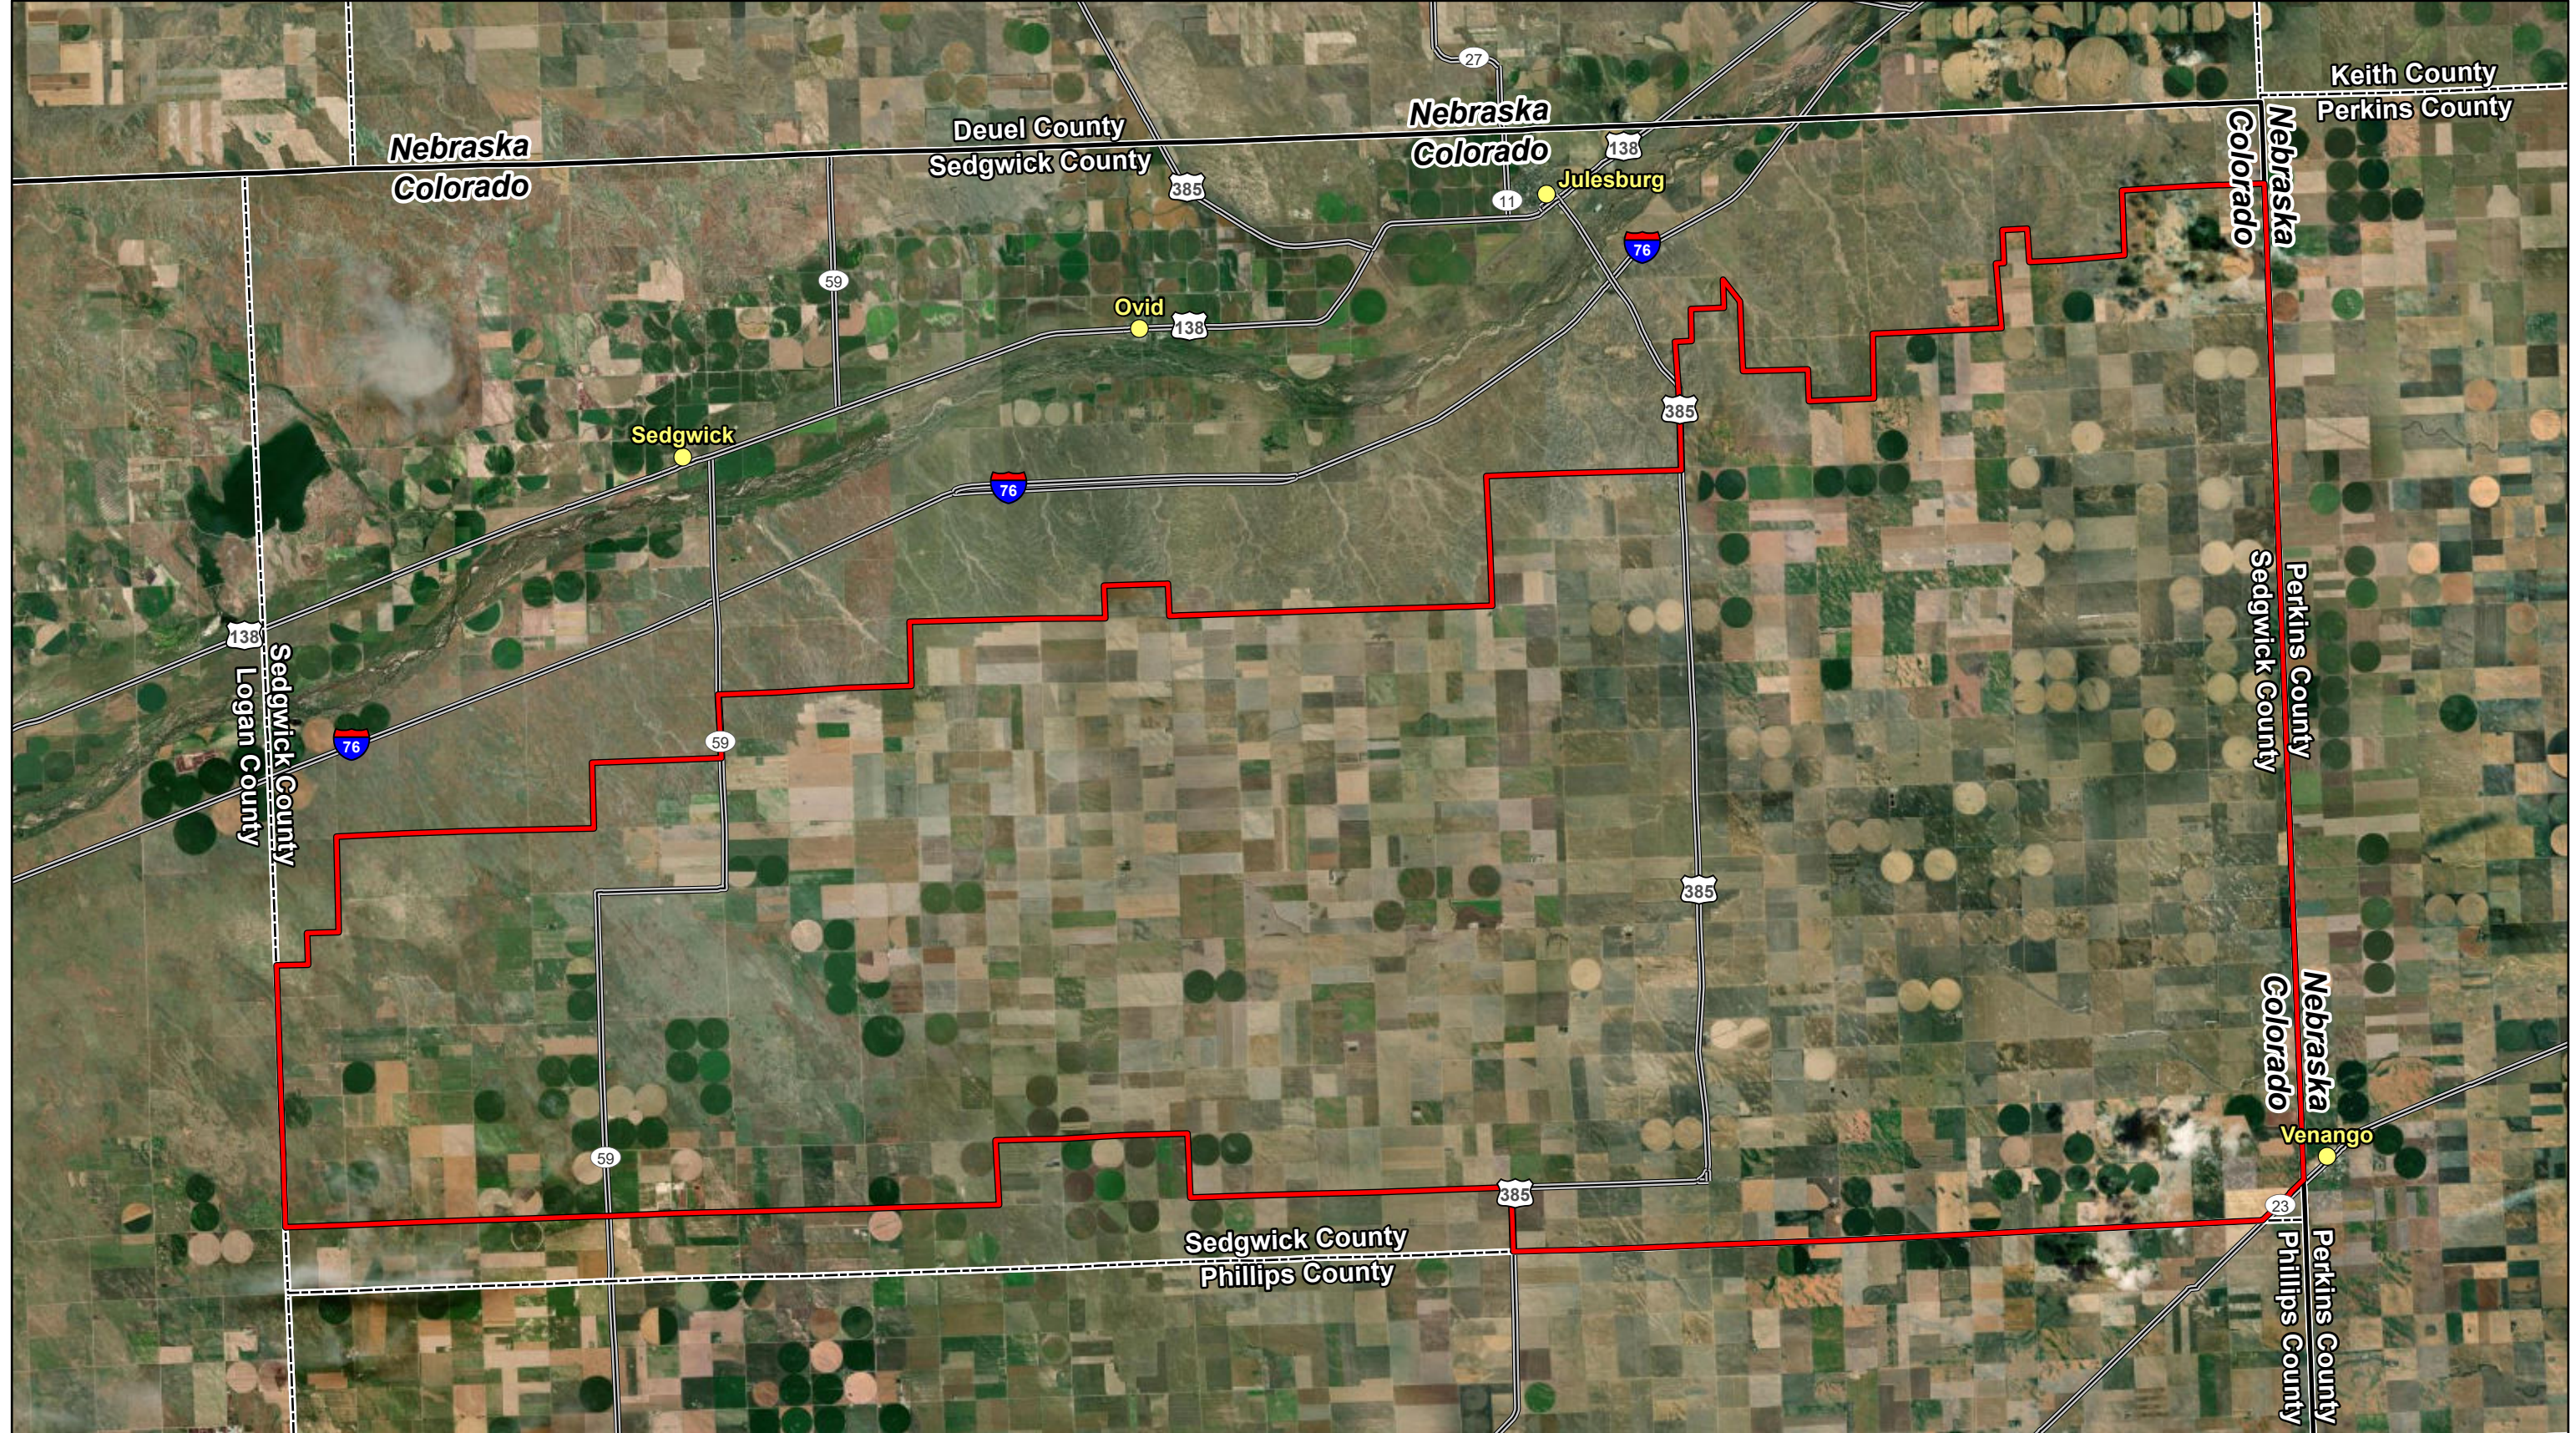
Data Source(s): Westwood (2024); ESRI WMS World Imagery Basemap (Accessed 2024); Census Bureau (2023).
